BULLETIN NO: 08 - 80

DATE: November 10, 1980.

SUBJECT: CR-2020

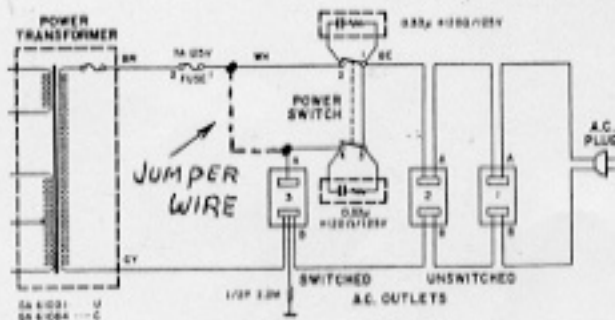
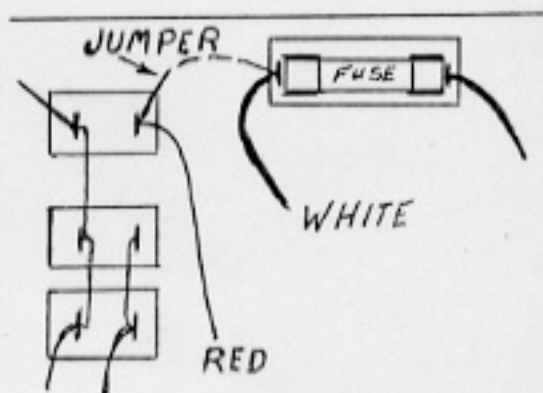
Problem: Power switch failure.

Cause: Pitting and burning of switch contact due to high current spike when set is switched off. (Back E.M.F. from power transformer).

Remedy: Replace power on/off switch (KA200630).
Install a jumper wire between the fuse holder (white wire) and the switched AC outlet (red wire).

Install the jumper wire on all units received for service that have not been modified.
